GlobalMET NEWSLETTER

On board training and Sea time issues – IMO Correspondence Group on Maritime Training

The Demise of EL FARO – A Wake up call for the World Merchant Marine

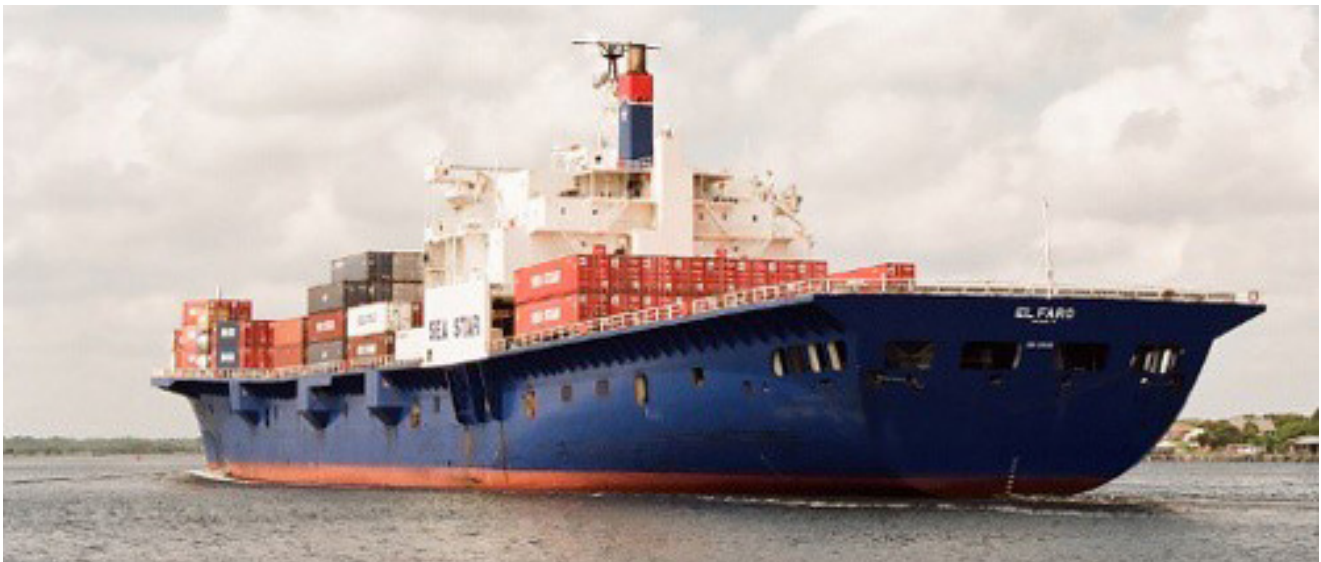
Figure 1 – *El Faro* (Source: NTSB)

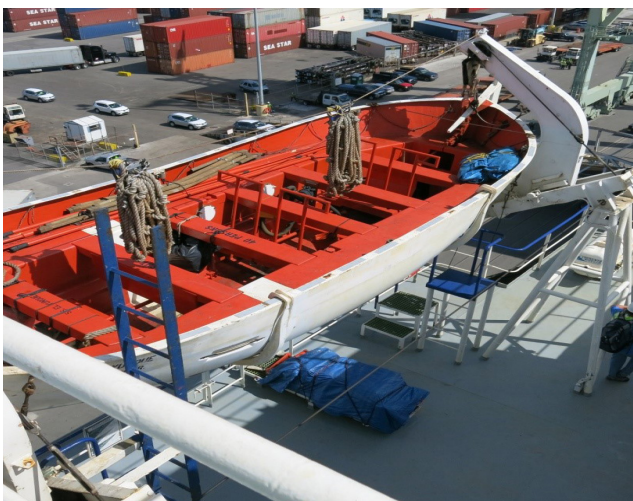
Figure 4 – Open Lifeboat of *El Yunque* sister ship of *El Faro*. (Source: NTSB)

El Faro had two bright orange open lifeboats of 43 persons capacity and 5 life rafts, each capable of holding 17 people. The crew found it impossible to launch any of these. With winds more than 120 mph, seas of 50 feet and higher, it was perilous to go on deck. During the final fateful hours, visibility was near zero. The port side lifeboat had a diesel engine for propulsion and the starboard life boat was propelled by means of Fleming gear.

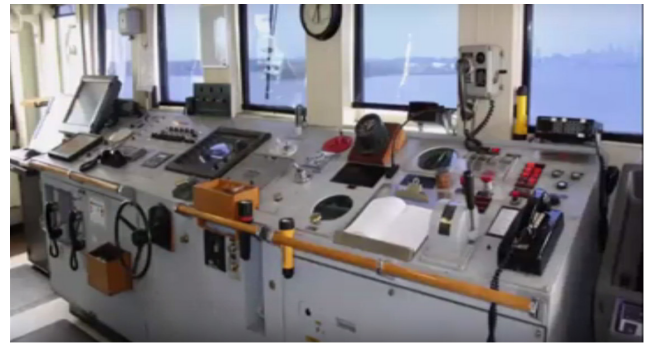
Figure 5 – Wheelhouse of *El Faro* (Source: NTSB)

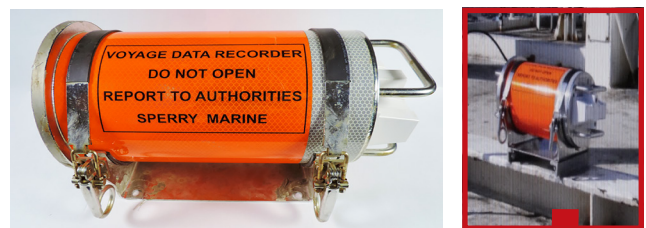
Figure 6 – S-VDR of *El Faro* (Source: NTSB)

- 18. **El Faro's S-VDR:** *El Faro* was not fitted with a VDR – rather, she was fitted with a Simplified Voyage Data Recorder (S-VDR) which was not designed to float free of the vessel. Simplified VDRs are targeted at the retrofit market (cargo ships built prior to 2002). Simplified VDRs record bridge audio and basic parametric data, but are generally not required to record more extensive parameters such as engine, steering, alarm, or wind data. Inside this fixed capsule, a 12 hour duration of data is recorded. This data includes audio from microphones on the bridge, Very High Frequency (VHF) radio communications, images captured from an onboard radar every 15 seconds, and Automatic Identification System (AIS) traffic broadcasts data (if not possible to record radar). Lastly, other vessel data is recorded, which includes date, time, GPS position, speed, and heading. The fixed capsule is certified to remain functional up to a depth 6,000 meters (about 20,000 feet). In the case of *El Faro*, the S-VDR was mounted on the antenna mast support structure above the bridge of the vessel. *El Faro's* S-VDR was finally found in May 2016. The analyzed data and audio files only brought out the agony that transpired amongst the ship's team during the occurrence of the sequence of events that led to *El Faro's* sinking.

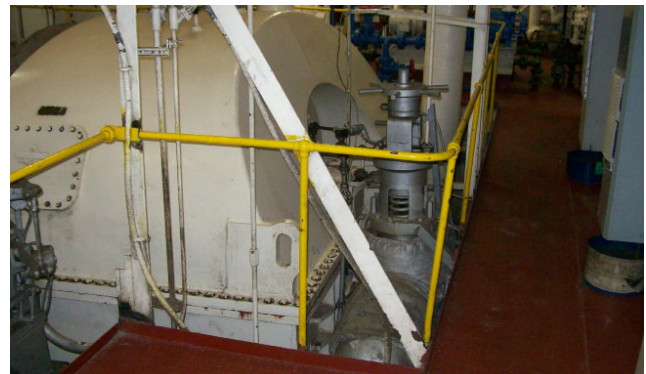
Figure 11 – Top Portion (Safety Valve) of Boiler of *El Faro* (Source: NTSB)

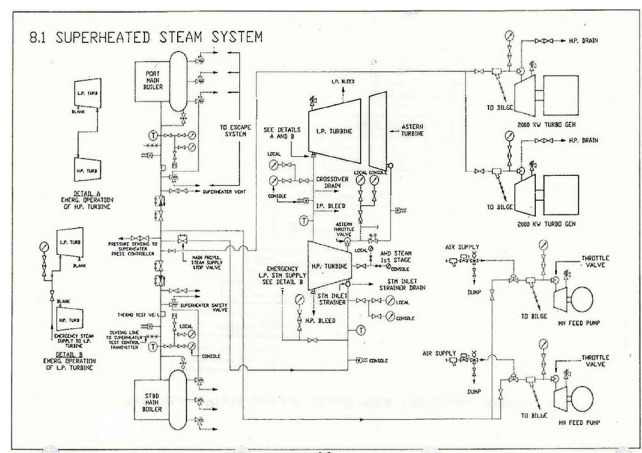
Figure 12 – Steam System of *El Faro* (Source: NTSB)

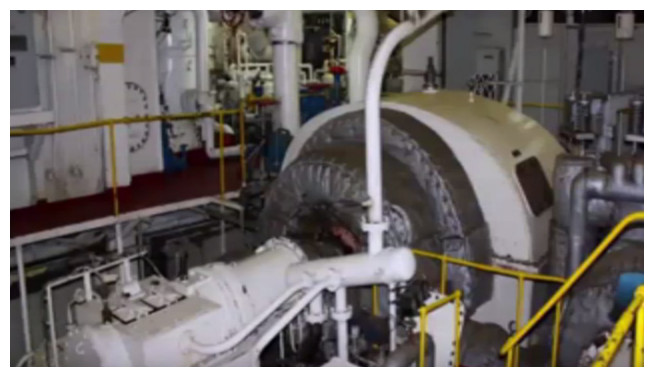
Figure 13 – Main Propulsion Turbine of *El Faro* (Source: NTSB)

As per SOLAS, all shipboard machinery should be fully functional even at a static heel of 15 degrees or a dynamic heel of 22.5 degrees. Steam turbines are generally considered to be a reliable piece of equipment. The major reasons for tripping of Steam Turbines could be overspeed, lub oil failure or loss of steam pressure. Loss of steam pressure from the boilers can cause loss of vacuum in the condenser and also speed reduction and stoppage of propulsion.

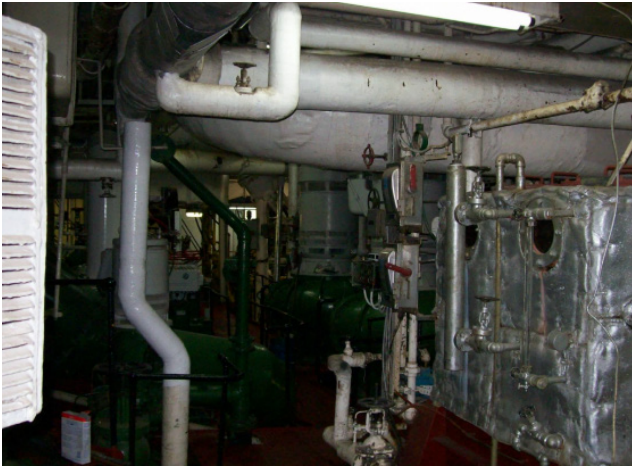
Figure 14 – Power Generation Turbines of *El Faro* (Source: NTSB)

- Power Generation:** In *El Faro*, power was generated through two steam turbine driven alternators. It may be the same condition as for the main propulsion turbines. It is unclear whether these two power generation steam turbines were functional when she listed to 15 degrees and more. *El Faro* did not have a backup diesel generator which could take up the sea going electrical load in case there was a problem with the boilers.

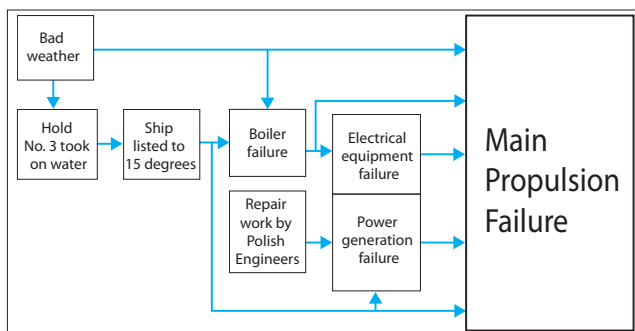
Figure 16 – Possible Causes of Main Propulsion Failure
(Source: the author)
